# EO Troubleshooting Guide

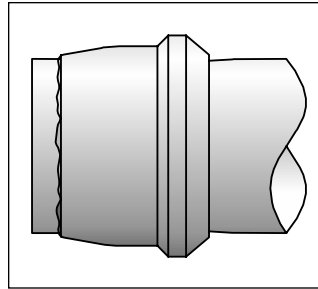
Problem	Solution
Tube not bottomed	Check for a visible mark on the tube end with EO fitting. (Fig. T47)
Shallow bite	Inspect for turned up ridge of material (collar). A failure to achieve this ridge can be traced either to the nut not being tightened enough or the tube not being bottomed against the stop which allowed the tube to travel forward with the ferrule. In some instances this assembly may be re-worked. (Fig. T48)
Over-set ferrule	Too much pressure or more than recommended turns from finger tight were used to pre-set ferrule, or the nut was severely over-tightened in final assembly. This assembly should be scrapped. (Fig. T49)
Ferrule cocked on tube	The ferrule may become cocked on the tube when the tube end is not properly lined up with the body. Generally, this condition is caused by faulty tube bending. All bent tube assemblies should drop into the fitting body prior to make up. This assembly should be scrapped. (Fig. T50)

Fig. T47 — Tube not bottomed

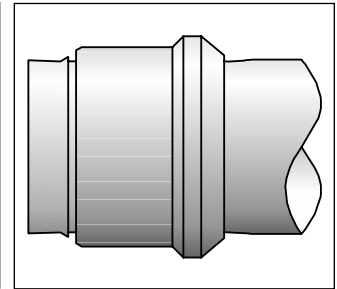
Fig. T48 — Shallow bite

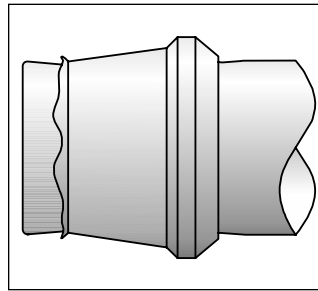
Fig. T49 — Over-set ferrule

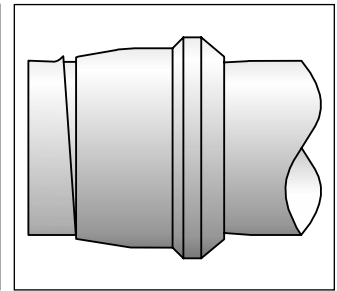
Fig. T50 — Ferrule cocked on tube
